## RESERVE STUDY WITH SITE VISIT

**KING'S CREEK HOA, DEER CREEK BLVD, SPRING HILL, TN 37174**

**Project Number:**  
24118

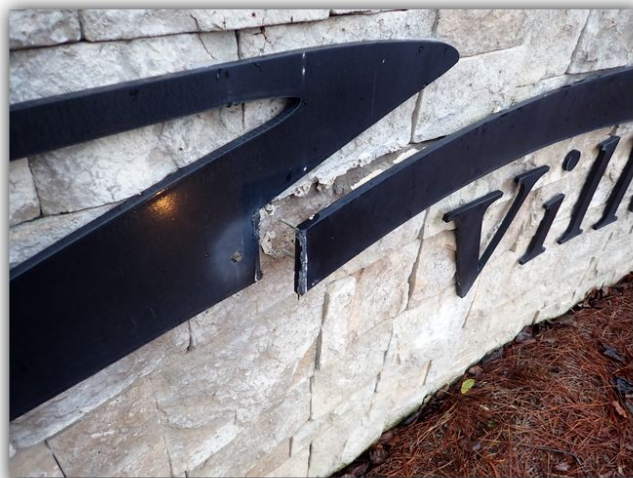
**Observations and Comments:** We observed a damaged metal sign on the west entrance monument at the Deer Creek Blvd property entrance. Refer to the following photo.

Entrance Monuments Component	Year
Entrance Monuments - Repair Allowance	2025 (5-year cycle)
Entrance Monuments - Replace	This line item has been included as a means to identify a future projection that is past the 30-year term of this study.

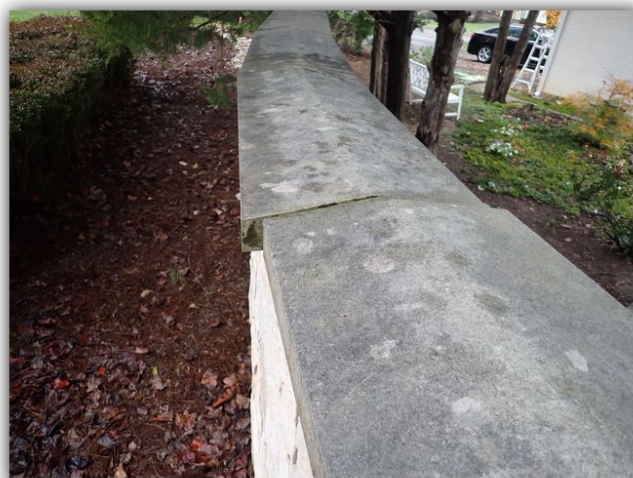
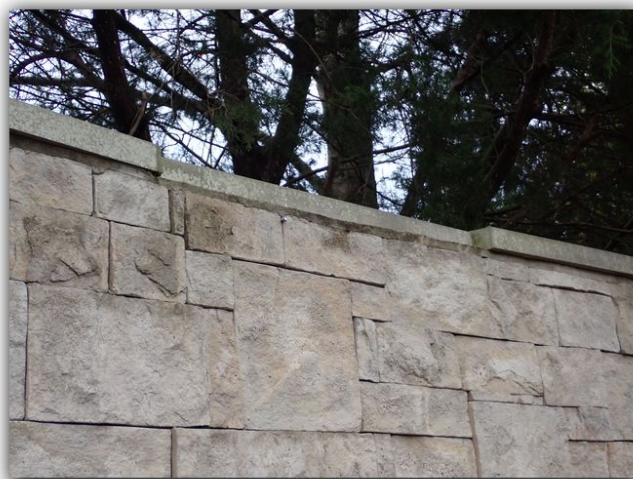
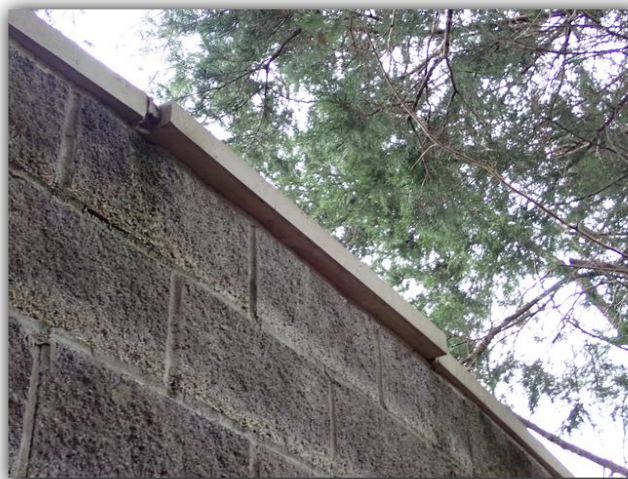
We observed evidence of shifted concrete caps along the top of the entrance monuments at the Deer Creek Blvd property entrance. Refer to the following photos.

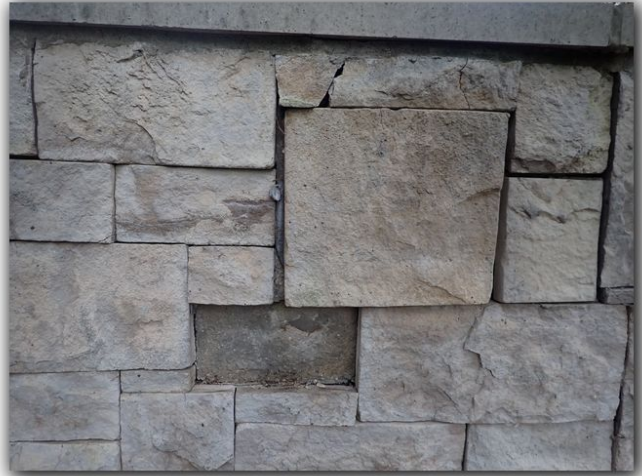
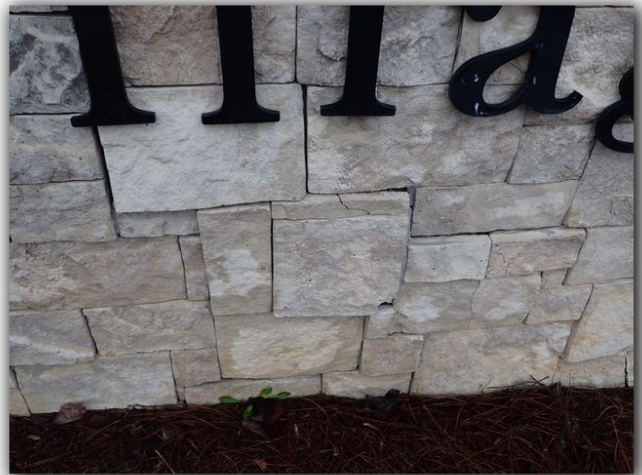
We observed evidence of loose and fallen stone veneer on the exteriors of the entrance monuments at the Deer Creek Blvd property entrance. Refer to the following photos.

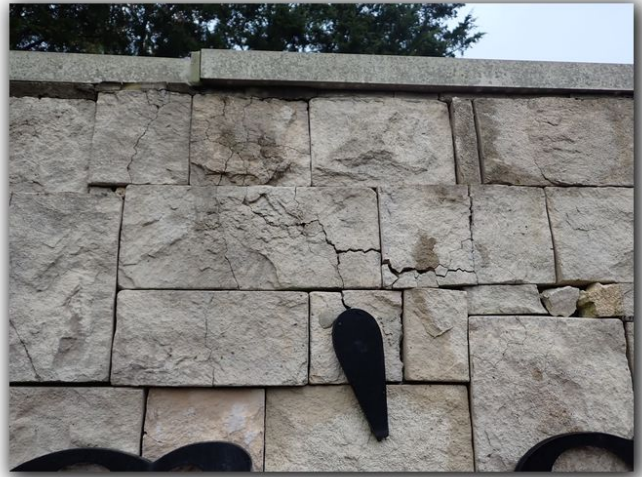
We observed some evidence of deteriorated and cracked stone veneer on the exteriors of the entrance monuments at the Deer Creek Blvd property entrance. Refer to the following photos.

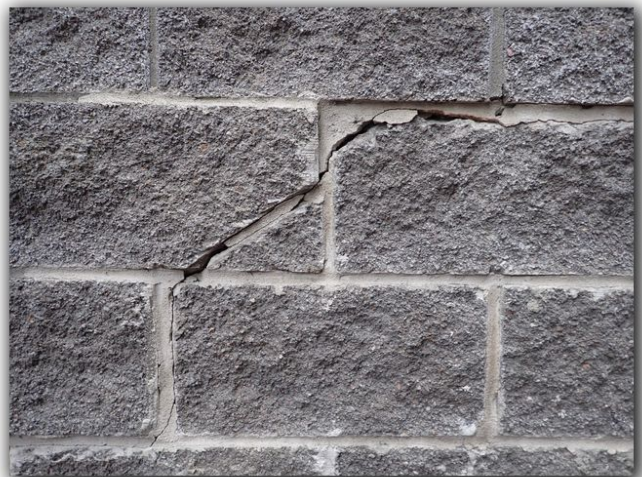
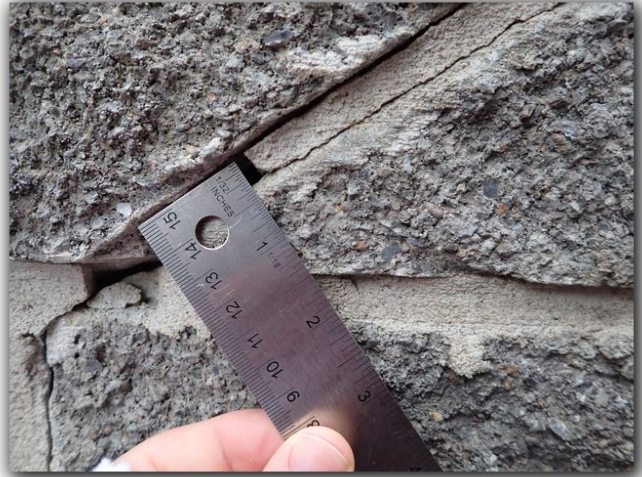
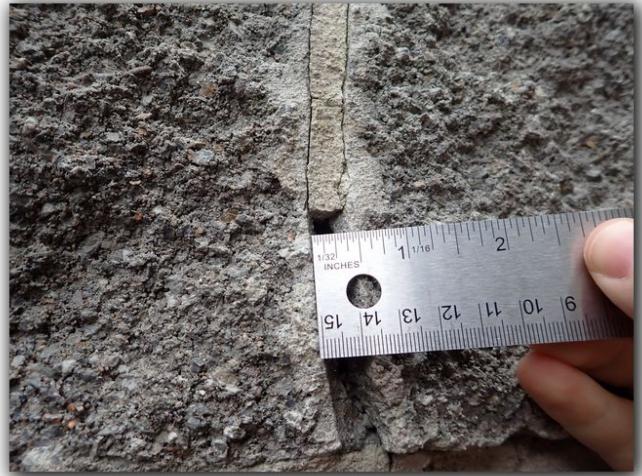
We observed some evidence of deteriorated mortar joints and cracking throughout the block exteriors of the entrance monuments at the Deer Creek Blvd property entrance. Refer to the following photos.

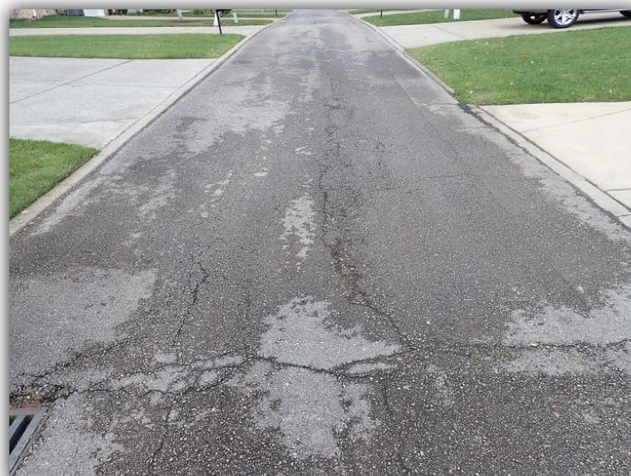
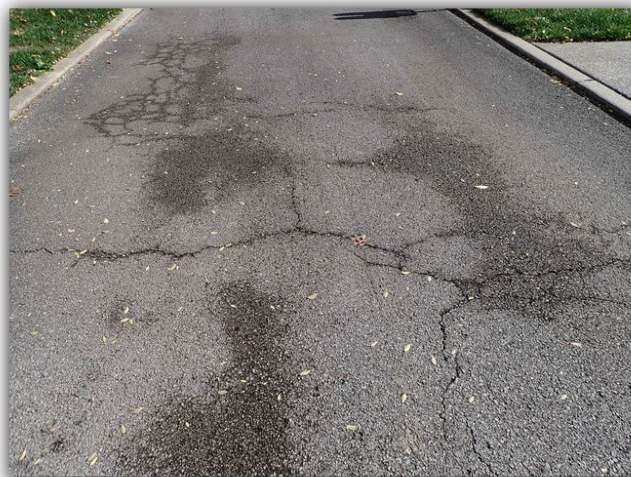
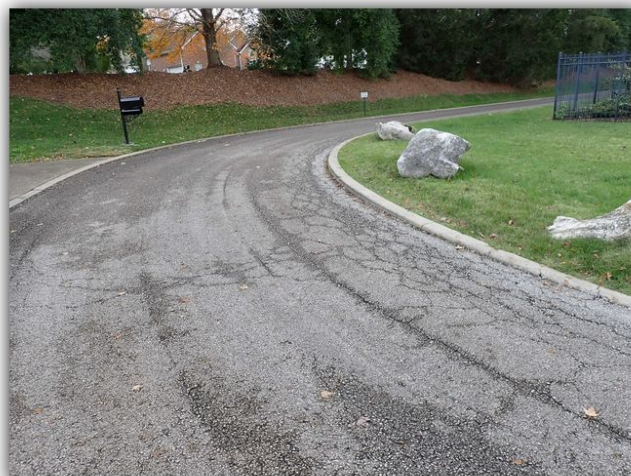
**Observations and Comments:** We observed general signs of cracking and surface deterioration throughout the private, asphalt-paved alleyways that serve the Cottage-style units. Refer to the following photos.

We recommend crack repair, patching, and sealing of the asphalt pavement every three-to-five years. This extends the life of the pavement and benefits the homeowners by maintaining the aesthetic appearance of the grounds and perceived value of the property. A seal coat is increasingly helpful where parked cars leak damaging fluids on the pavement.

Asphalt Paving Component	Year
Asphalt Alleyways Pavement - Patch, Crack Repair, & Seal	2025 (4-year cycle)
Asphalt Alleyways Pavement - Mill & Overlay	2033

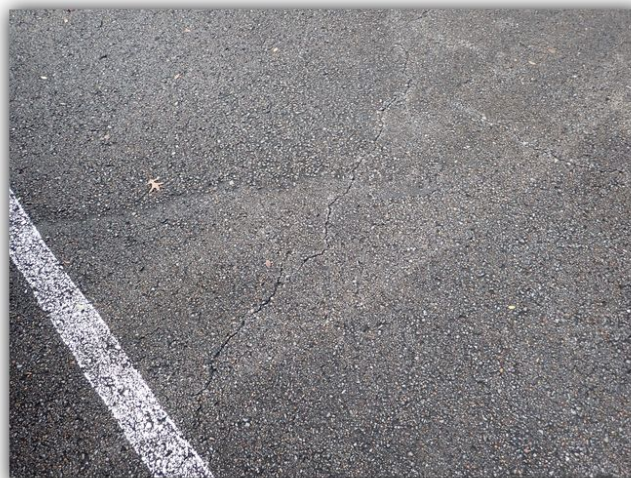
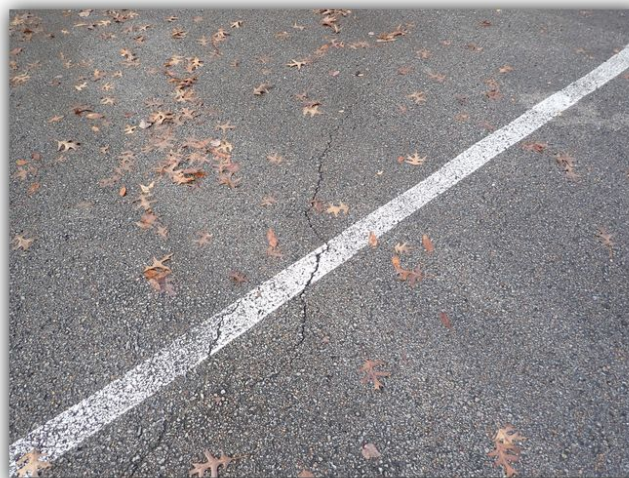
We observed some evidence of cracking and surface deterioration throughout the private, asphalt-paved road and parking area that serves the swimming pool area. Refer to the following photos.

Asphalt Paving Component	Year
Asphalt Pool Parking Pavement - Patch, Crack Repair, & Seal	2025 (4-year cycle)
Asphalt Pool Parking Pavement - Mill & Overlay	2033

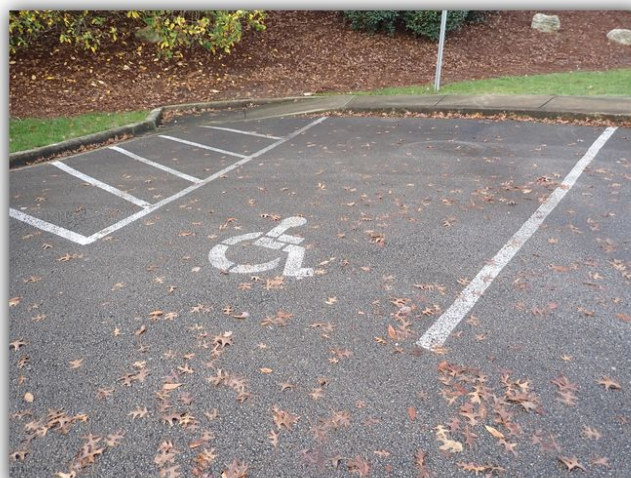
We observed evidence of deteriorated and fading parking space markings at the swimming pool parking area. Refer to the following photo.

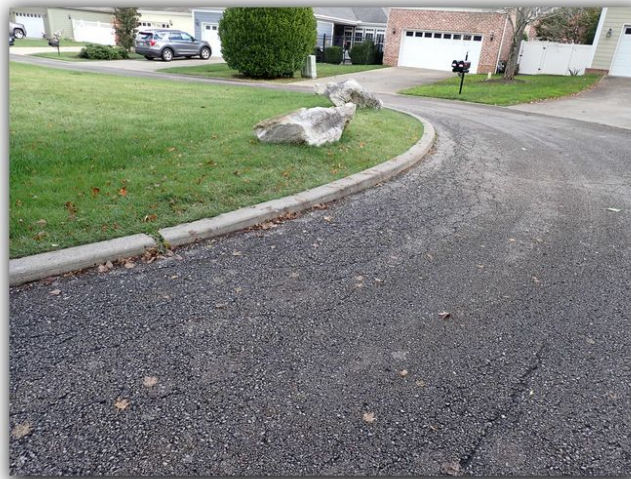
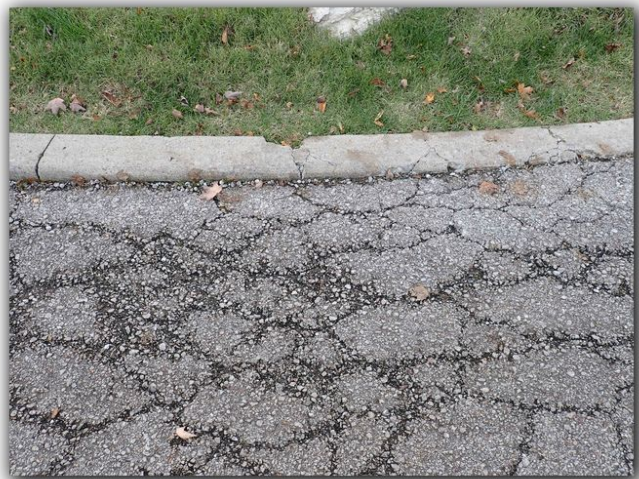
**Observations and Comments:** We observed general signs of deterioration and cracking throughout the concrete curbs along the private alleyways and parking areas that serve the Cottage-style units. Refer to the following photos.

Concrete sidewalks and curbs have an estimated useful life of over 50 years. Because they are generally not replaced all at once, but are replaced as sections fail, we have included an allowance toward the repair of 5% of the concrete curbs and sidewalks on a 5-year cycle beginning in 2027.

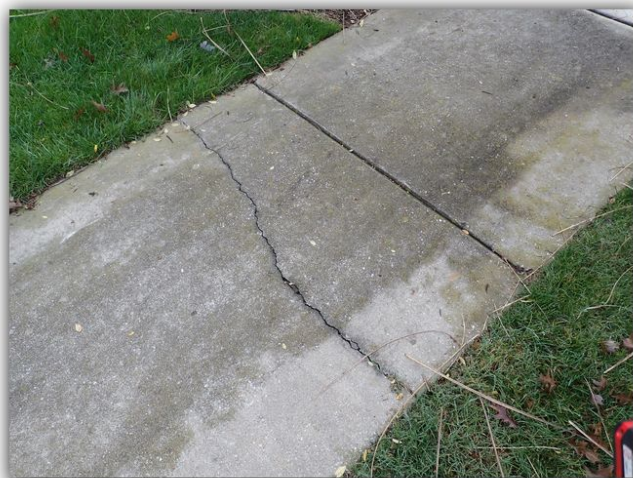
We observed general signs of cracking throughout the concrete sidewalks that serve the swimming pool area. Refer to the following photo.

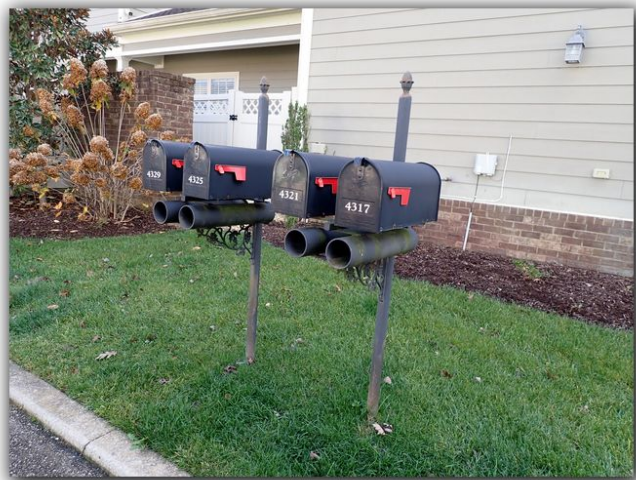
**Observations and Comments:** We observed general signs of organic-growth on the mailbox posts. Refer to the following photo.

Mailboxes Component	Year
Mailbox Posts - Paint	2027 (5-year cycle)
Mailbox Posts - Replace	This line item has been included as a means to identify a future projection that is past the 30-year term of this study.

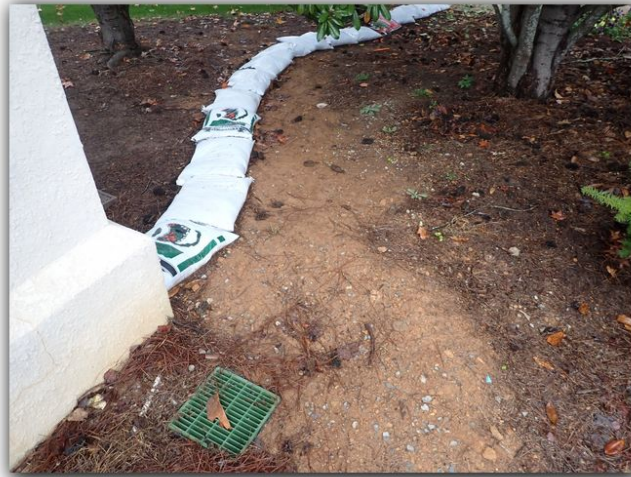
**Observations and Comments:** We observed some evidence of recent storm water drainage repairs around the entrance monuments at the main entrance to the property on Deer Creek Blvd. Refer to the following photo.

We have included an allowance toward storm water management system repairs and maintenance on a 2-year cycle beginning in 2025.

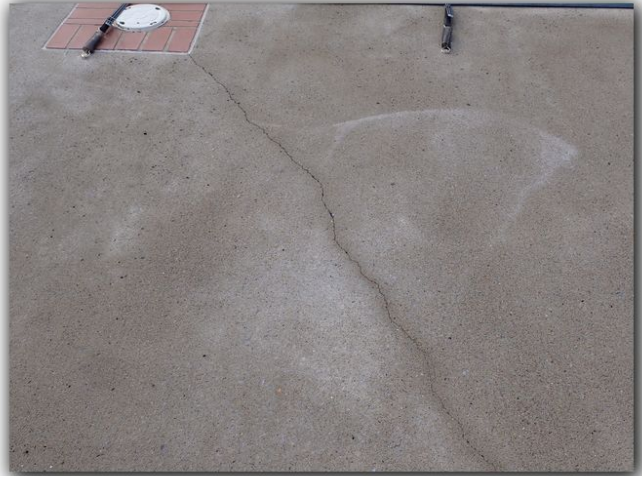
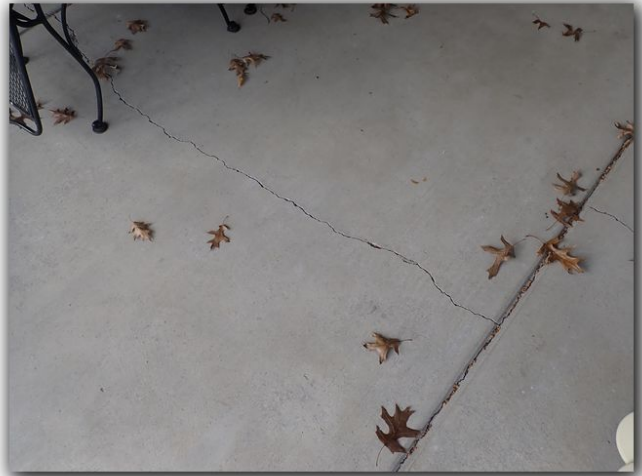
**Observations and Comments:** We observed general signs of cracking throughout the swimming pool concrete deck. Refer to the following photos.

Swimming Pool Area Component	Year
Swimming Pool Concrete Deck - Repair Allowance	2026 (5-year cycle)
Swimming Pool Concrete Deck - Replace	This line item has been included as a means to identify a future projection that is past the 30-year term of this study.
Swimming Pool Aluminum Perimeter Fence - Replace	2051
Swimming Pool - Replaster	2025 (8-year cycle)
Swimming Pool Waterline Tile - Replace	2025
Swimming Pool Brick Coping - Replace	2033
Swimming Pool Cover - Replace	2033 (10-year cycle)
Swimming Pool Vinyl-Strap Furniture - Re-Strap	2031 (10-year cycle)
Swimming Pool Vinyl-Strap Furniture - Replace	2026 (10-year cycle)
Swimming Pool Tables & Wrought Iron Chairs - Replace	2036
Swimming Pool Pump - Replace	2028 (10-year cycle)

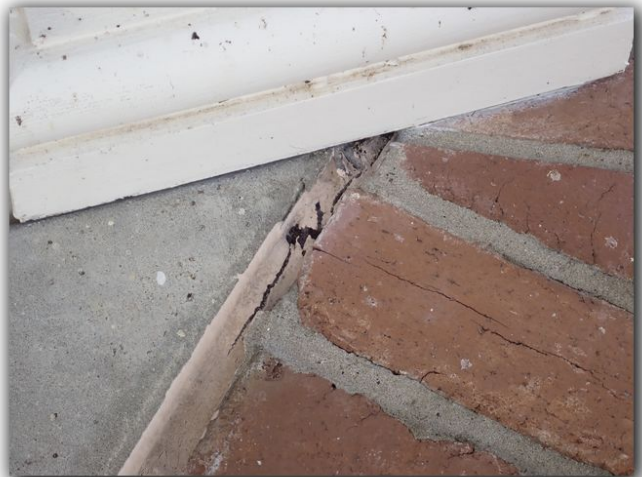
We observed general signs of deteriorated sealant between the concrete swimming pool deck and brick perimeters. Refer to the following photos.

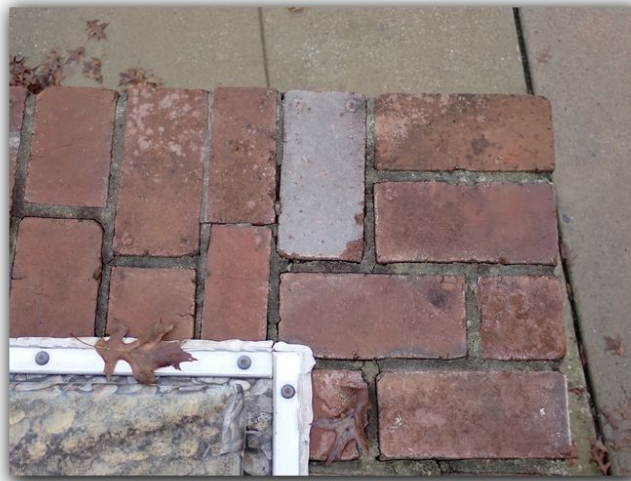
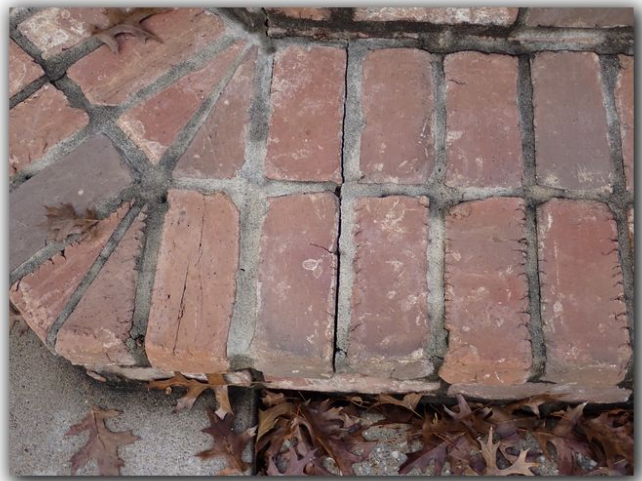
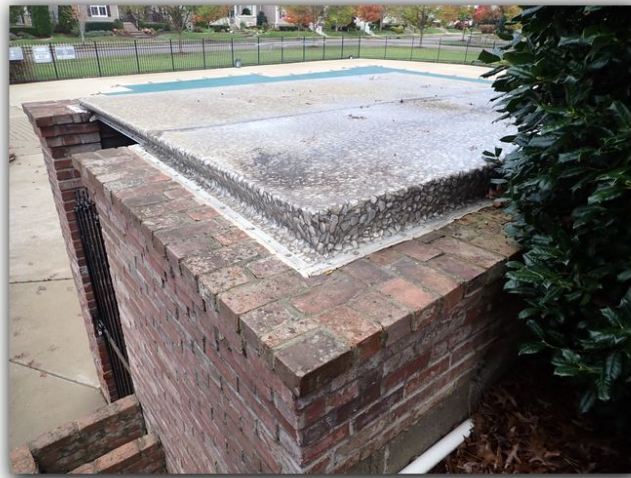
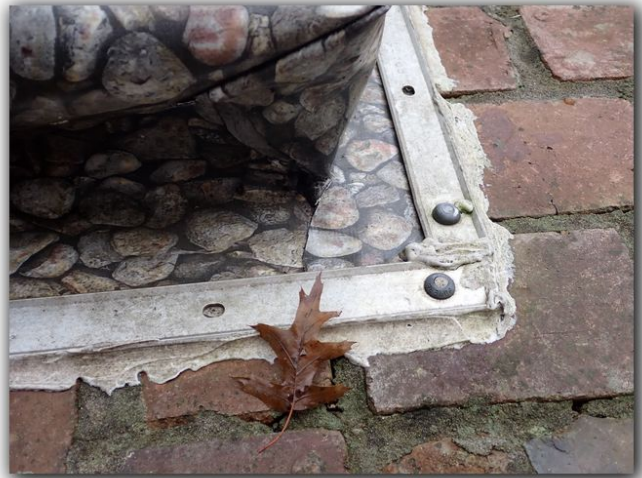
We observed general signs of deteriorated mortar joints, cracking, and minor damage throughout the swimming pool mechanical equipment building. Refer to the following photos.

Swimming Pool Area Component	Year
Swimming Pool Filters - Replace	2025
Swimming Pool Salt Systems - Replace	2026 (10-year cycle)
Swimming Pool Plumbing Systems - Allowance	2025
Swimming Pool Equipment Building - Repair Allowance	2025 (10-year cycle)

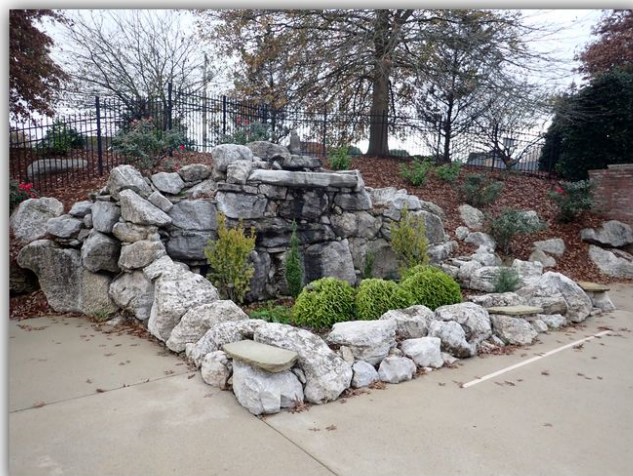
Based on information provided by the HOA Board and Community Manager, we understand that the swimming pool area fountain is no longer working and will likely be removed in the future.

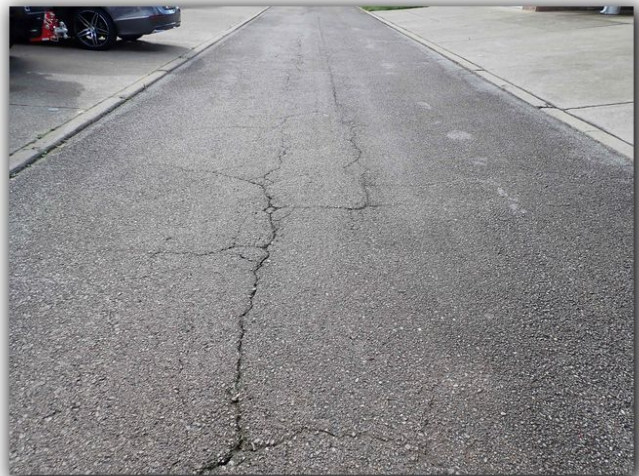
**Observations and Comments:** We observed general signs of cracking and surface deterioration throughout the private, asphalt-paved alleyways that serve the Townhome-style units. Refer to the following photos.

We recommend crack repair, patching, and sealing of the asphalt pavement every three-to-five years. This extends the life of the pavement and benefits the homeowners by maintaining the aesthetic appearance of the grounds and perceived value of the property. A seal coat is increasingly helpful where parked cars leak damaging fluids on the pavement.

Townhome Asphalt Paving Component	Year
Asphalt Alleyways Pavement - Patch, Crack Repair, & Seal	2025 (4-year cycle)
Asphalt Alleyways Pavement - Mill & Overlay	2033

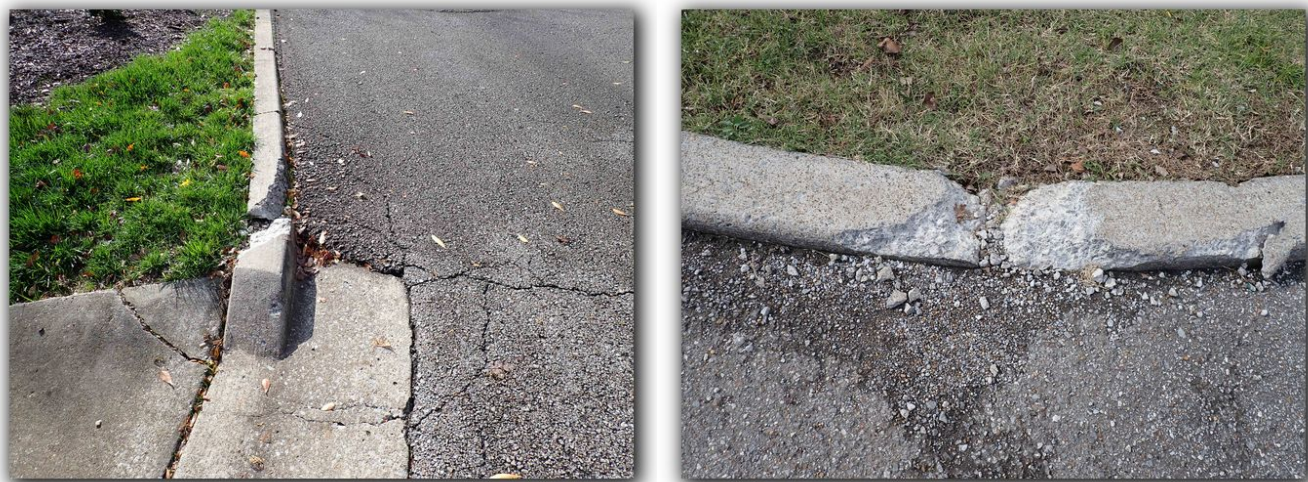
**Observations and Comments:** We observed general signs of deterioration and cracking throughout the concrete curbs along the private alleyways that serve the Townhome-style units. Refer to the following photos.

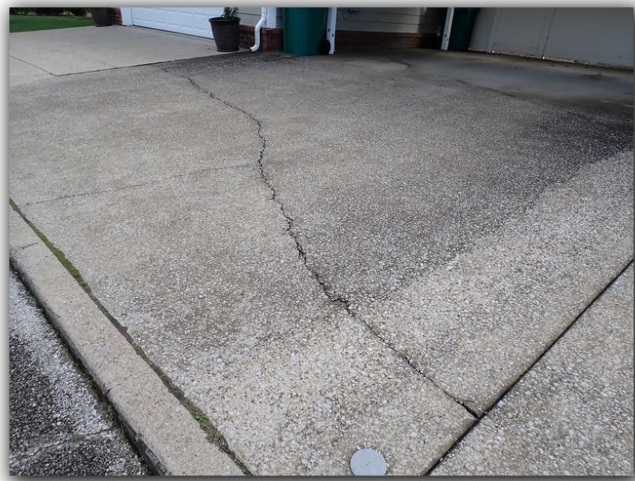
**Observations and Comments:** We observed general signs of cracking and surface deterioration throughout the Townhome concrete driveways and parking pads. Refer to the following photo.

Concrete porches, patios, and driveways have an estimated useful life of over 50 years. Because they are generally not replaced all at once, but are replaced as sections fail, we have included an allowance toward the repair of 5% of the concrete porches, patios, and driveways on a 5-year cycle beginning in 2029.

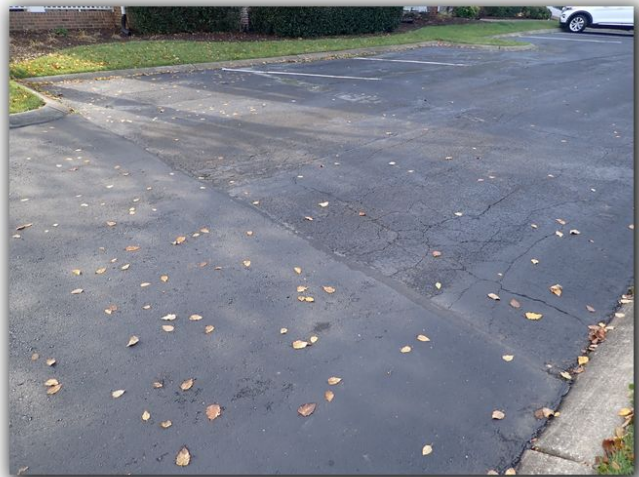
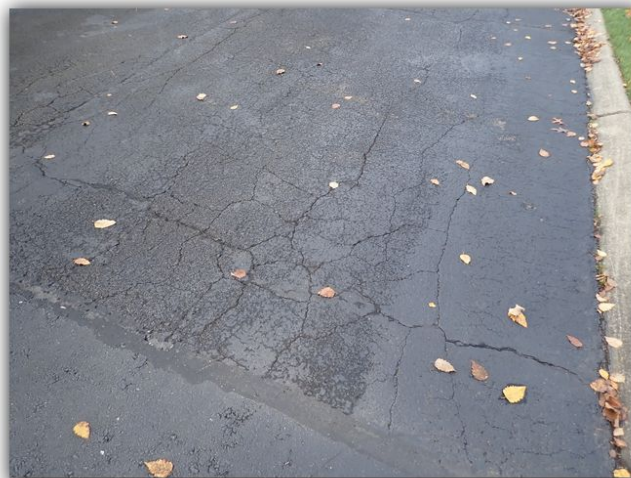
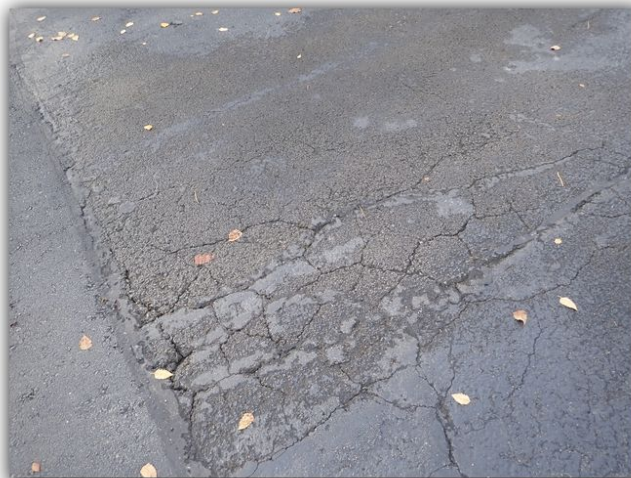
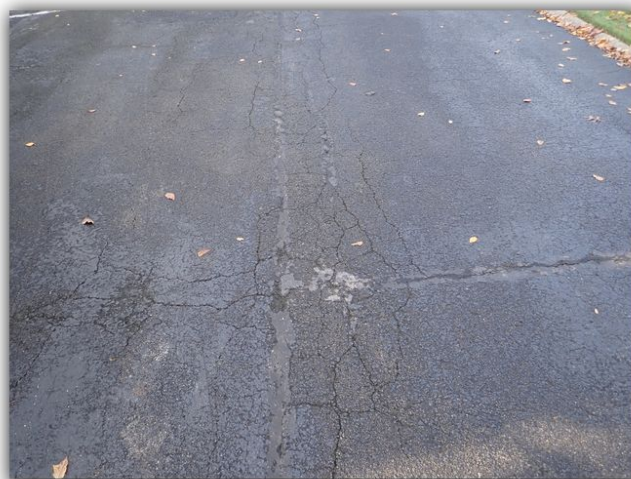
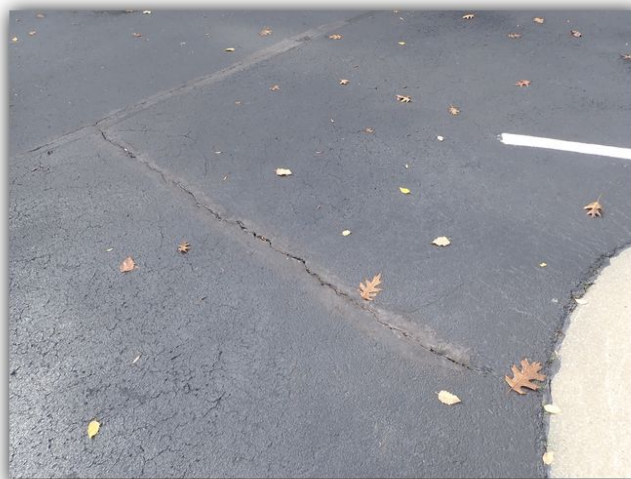
**Observations and Comments:** We observed general signs of cracking and surface deterioration throughout the asphalt pavement that serves the condominium building. Refer to the following photos.

We recommend crack repair, patching, and sealing of the asphalt pavement every three-to-five years. This extends the life of the pavement and benefits the homeowners by maintaining the aesthetic appearance of the grounds and perceived value of the property. A seal coat is increasingly helpful where parked cars leak damaging fluids on the pavement.

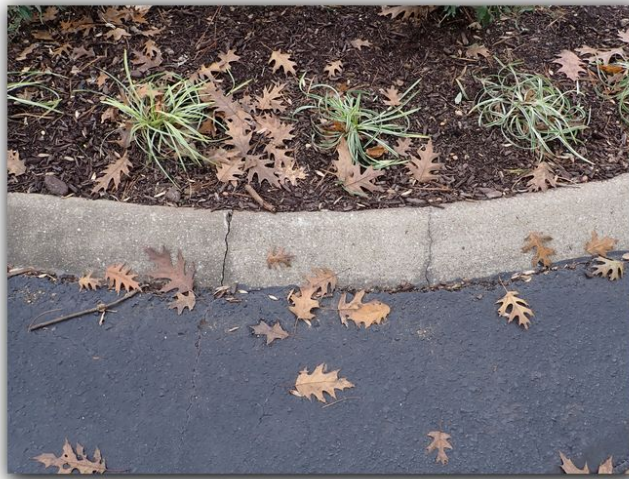
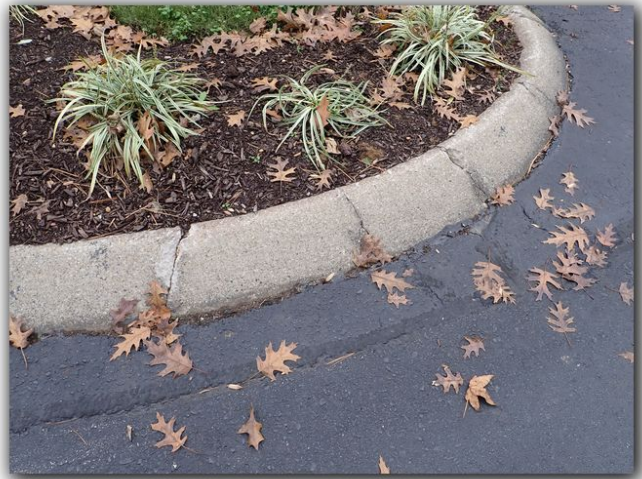
**Observations and Comments:** We observed general signs of deterioration and cracking throughout the concrete curbs along the perimeter of the condominium building pavement. Refer to the following photos.

Concrete sidewalks and curbs have an estimated useful life of over 50 years. Because they are generally not replaced all at once, but are replaced as sections fail, we have included an allowance toward the repair of 5% of the concrete curbs and sidewalks on a 5-year cycle beginning in 2027.

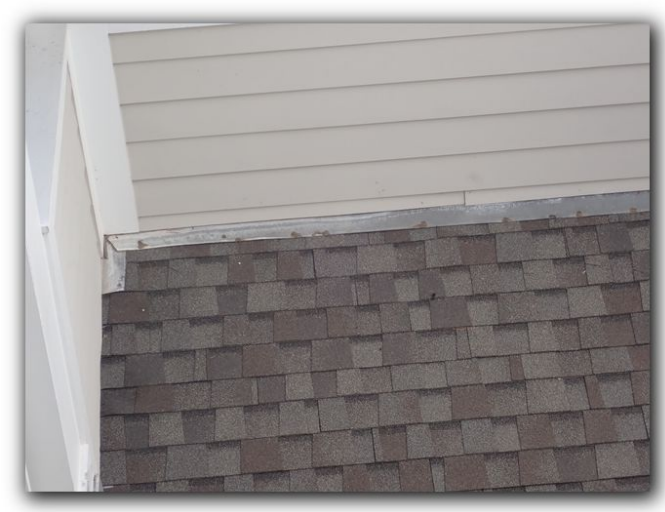
**Observations and Comments:** Based on information provided by the HOA Board and Community Manager, we understand that the aluminum flashing was not replaced during the last roof replacement project. We anticipate that the flashing will be replaced during the next roof replacement project.

Condominium Building Roofing Component	Year
Asphalt Shingle Roof Covering & Aluminum Flashing - Replace	2042
Aluminum Gutters & Downspouts - Replace	2035

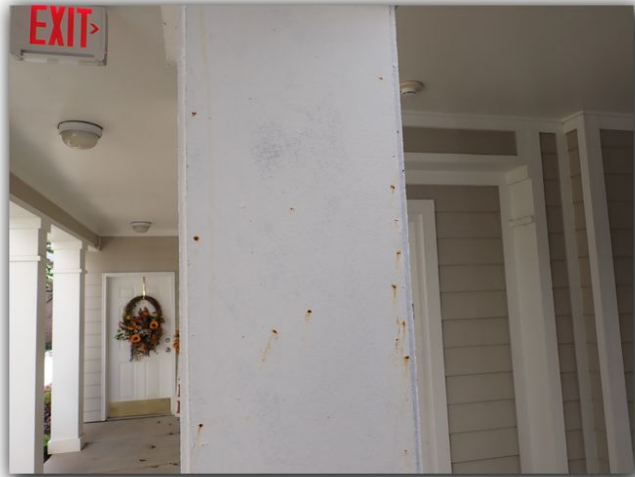
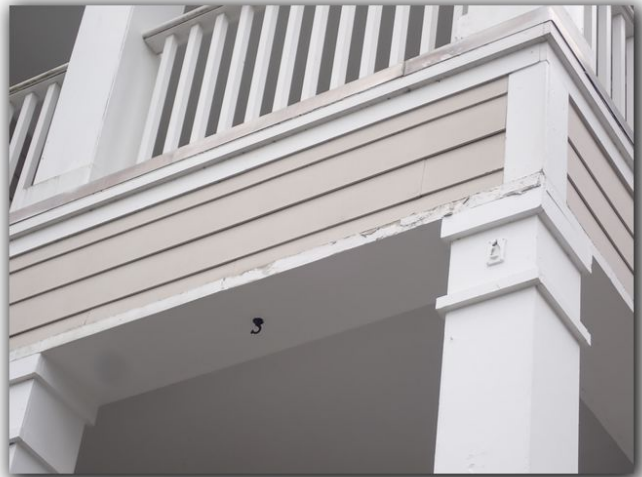
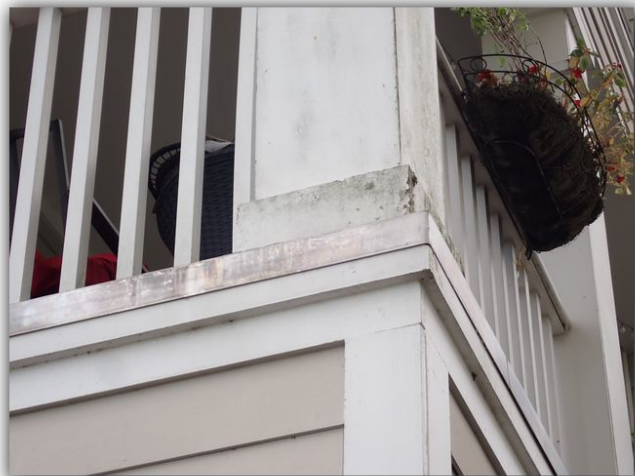
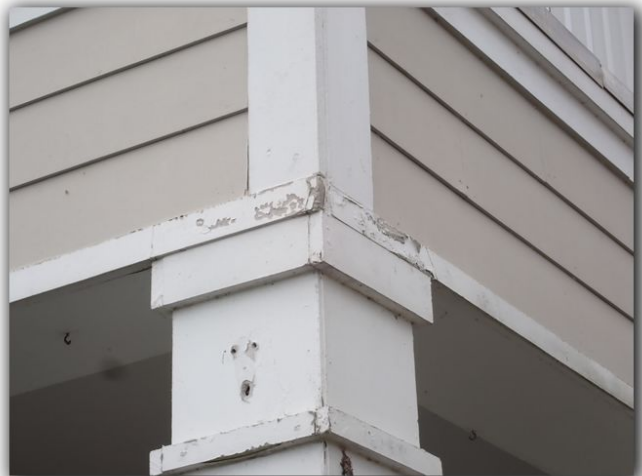
**Observations and Comments:** We observed general signs of deteriorated paint throughout the condominium building exterior. Refer to the following photos.

Condominium Building Exterior Component	Year
Building Exterior, Corridors, & Stairwells - Repair & Paint	2025 (8-year cycle)
Fiber Cement Siding, Soffit, & Fascia - Replace	This line item has been included as a means to identify a future projection that is past the 30-year term of this study.
Exterior Light Fixtures - Replace	2030
Unit Entrance & Mechanical Room Doors - Replace	2045
Unit Balcony Doors - Replace	2045
Exterior Windows - Replace	2040
Vinyl Shutters - Replace	2030
Concrete Corridor Floors - Repair Allowance	2027 (5-year cycle)
Steel Handrails - Replace	This line item has been included as a means to identify a future projection that is past the 30-year term of this study.
Steel & Concrete Stair Structures - Repair Allowance	2029 (5-year cycle)
Steel & Concrete Stair Structures - Replace	This line item has been included as a means to identify a future projection that is past the 30-year term of this study.

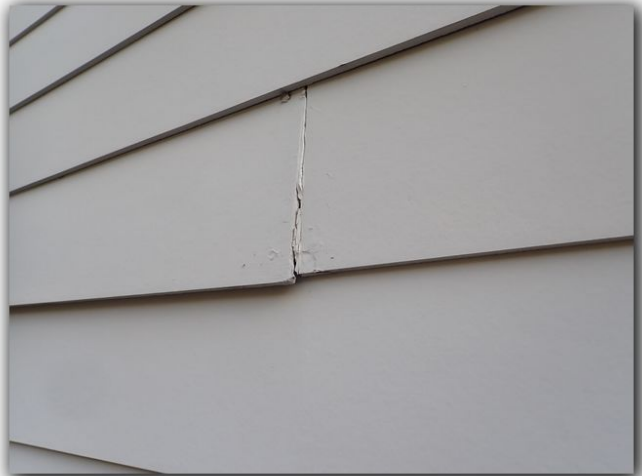
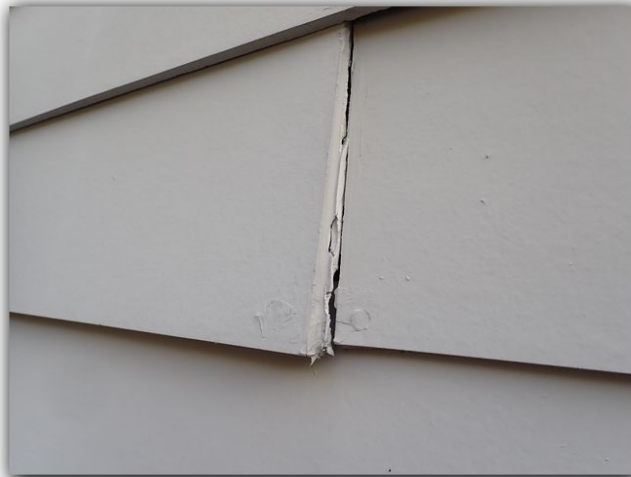
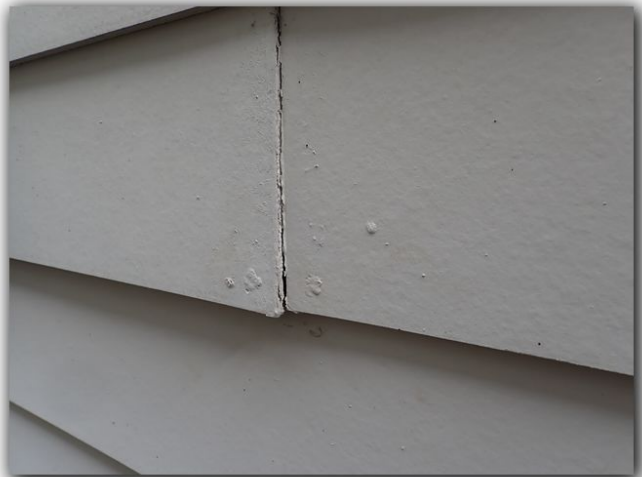
We observed general signs of deteriorated sealant throughout the fiber cement exteriors of the condominium building. Refer to the following photos.

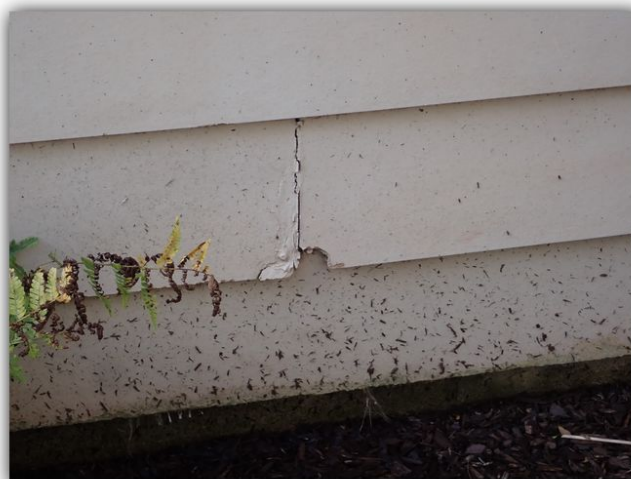
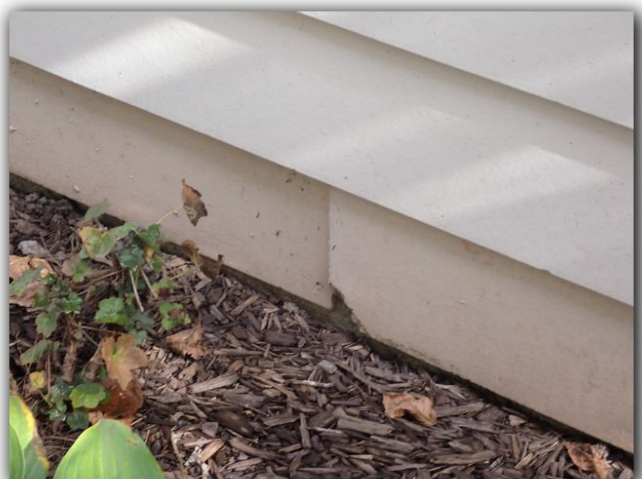
We observed some sections of damaged fiber cement siding near the bottom exteriors of the condominium building. Refer to the following photos.

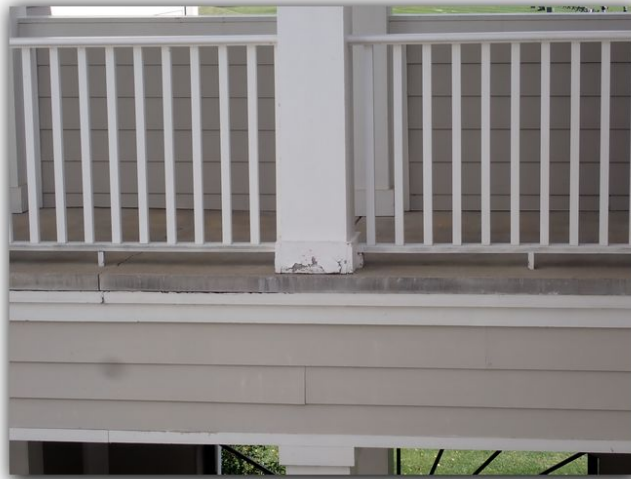
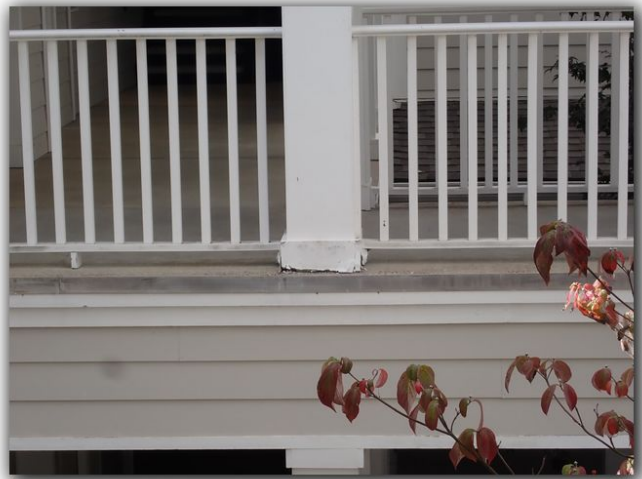
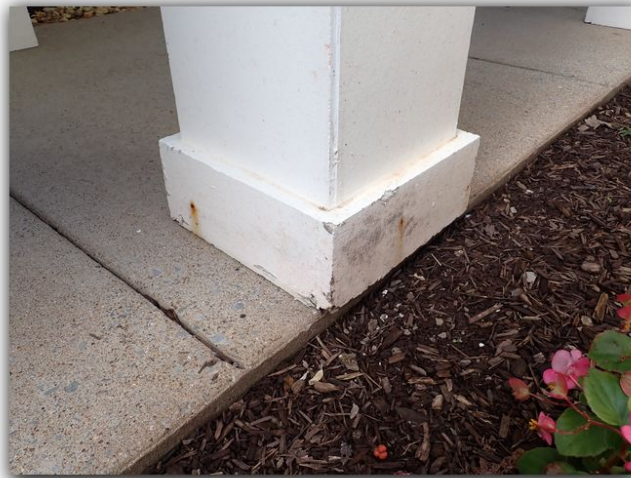
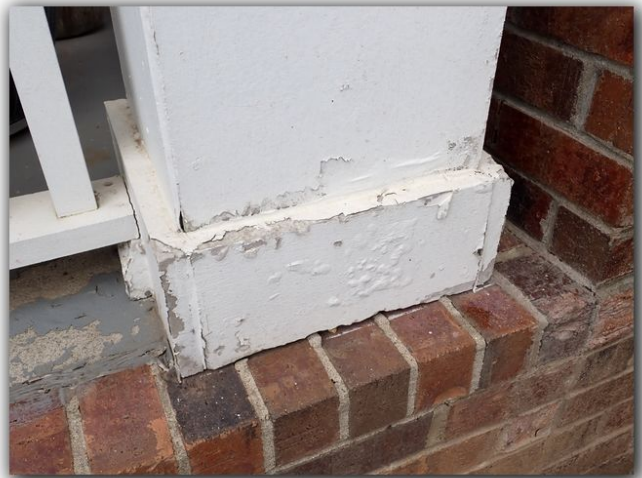
We observed general signs of deteriorated paint and potential rot throughout the bases of the columns that support the elevated balconies and walkways of the condominium building. Refer to the following photos.

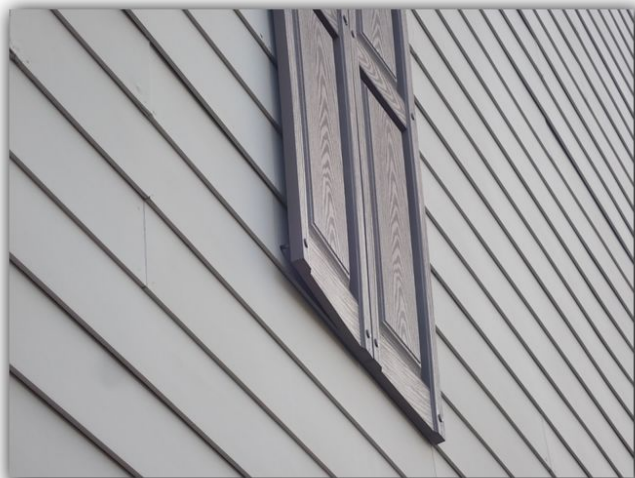
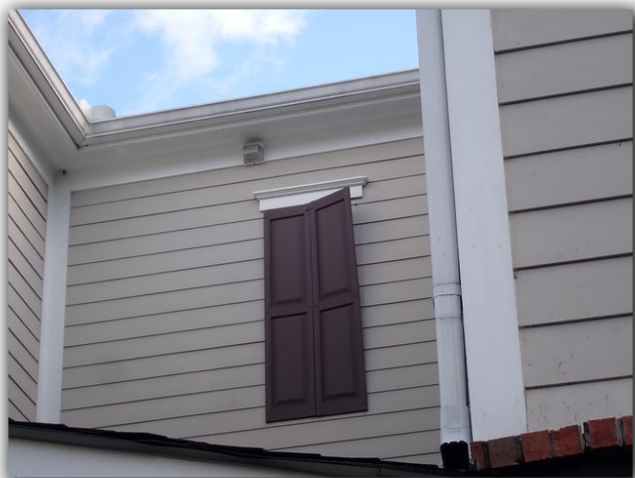
We observed some loose and unsecured vinyl shutters on the exterior of the condominium building. Refer to the following photos.

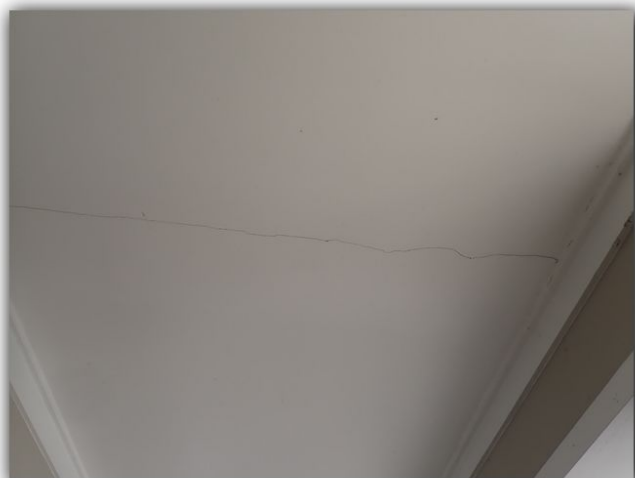
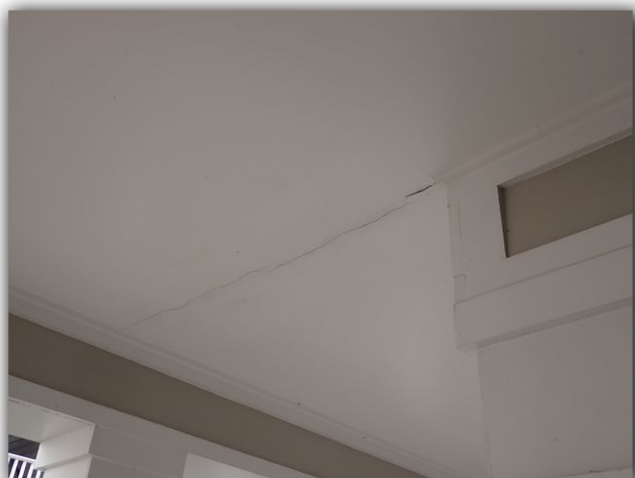
We observed some evidence of cracks in the ceilings of the elevated walkways at the condominium building. Refer to the following photos.

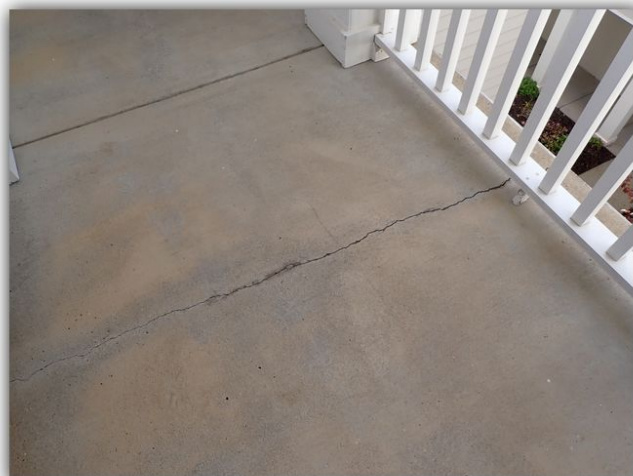
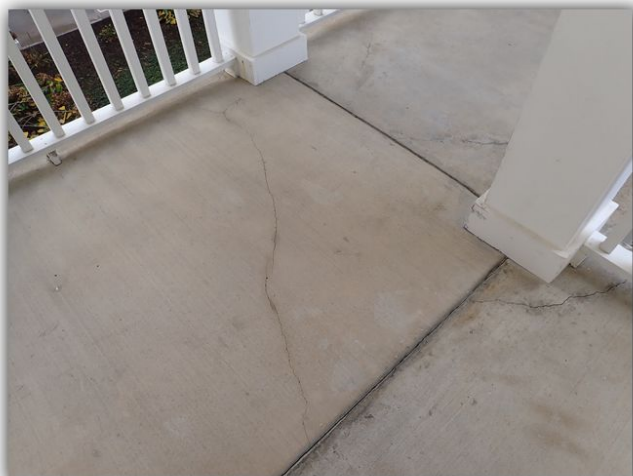
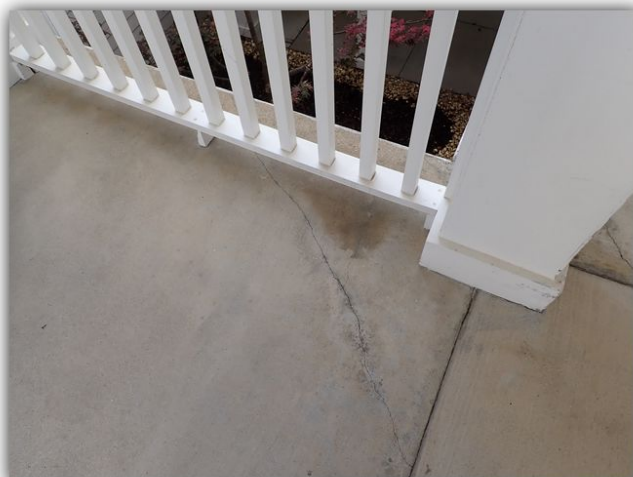
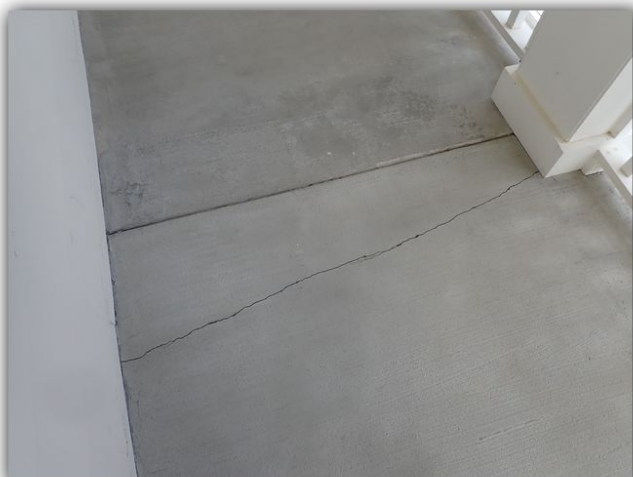
We observed general signs of cracking throughout the ground-level and elevated concrete walkways of the condominium building. Refer to the following photos.

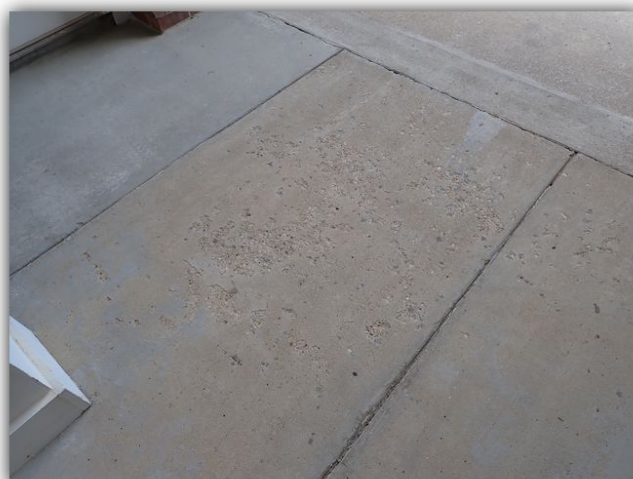
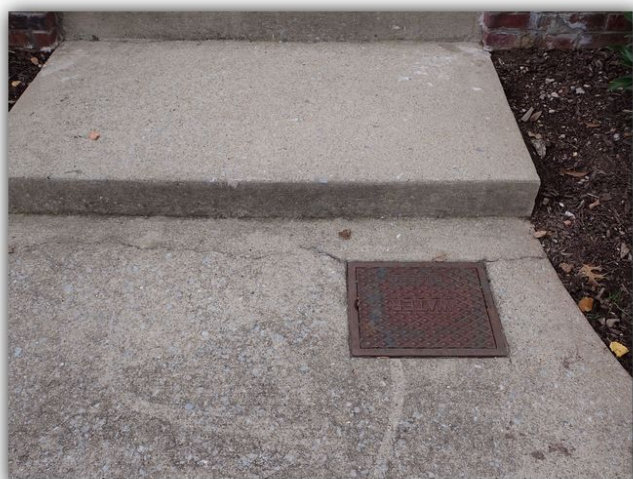
We observed general signs of surface deterioration throughout the uncovered concrete walkways around the condominium building. Refer to the following photos.
