## RESERVE STUDY WITH SITE VISIT

**KING'S CREEK HOA, DEER CREEK BLVD, SPRING HILL, TN 37174**

**Project Number:**  
24118

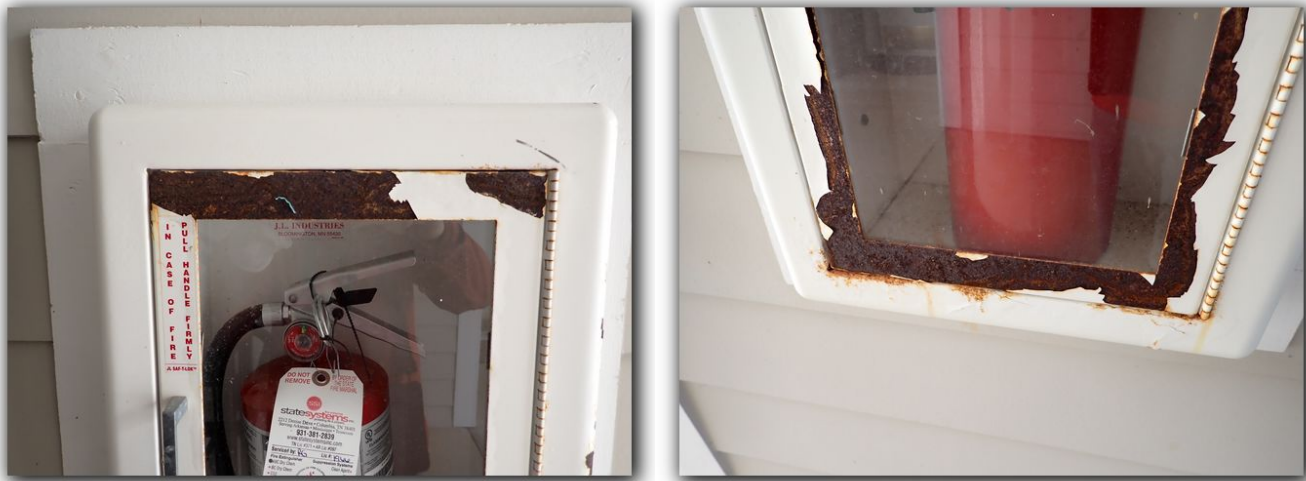
**Observations and Comments:** We observed evidence of deteriorated paint and rust throughout the fire extinguisher cabinets. Refer to the following photos.

Condominium Building Fire Protection Component	Year
Fire Protection Systems - Repair Allowance	2026 (2-year cycle)
Fire Protection System - Mechanical Overhaul	This line item has been included as a means to identify a future projection that is past the 30-year term of this study.

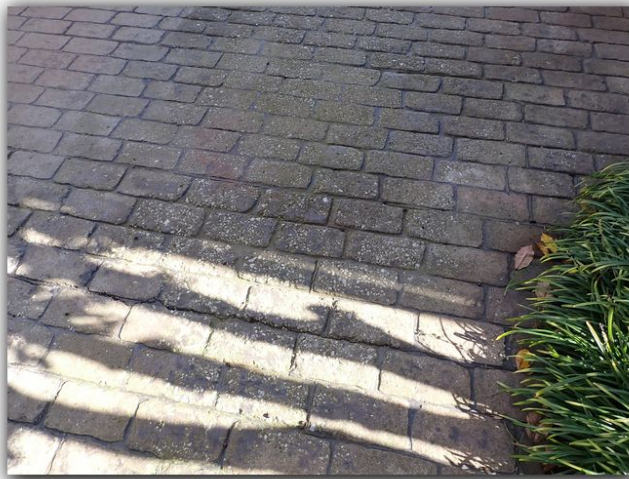
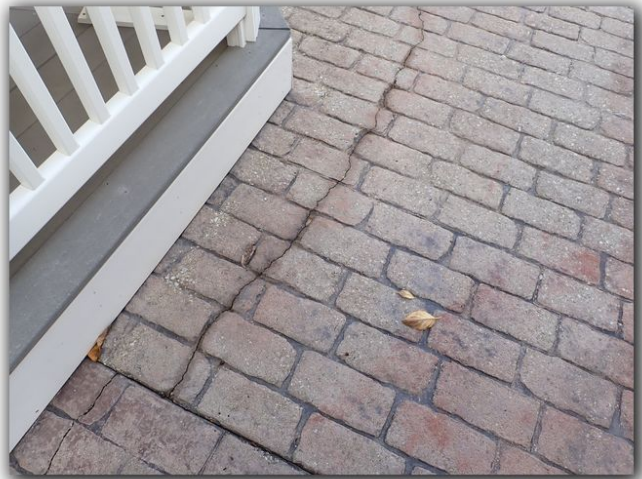
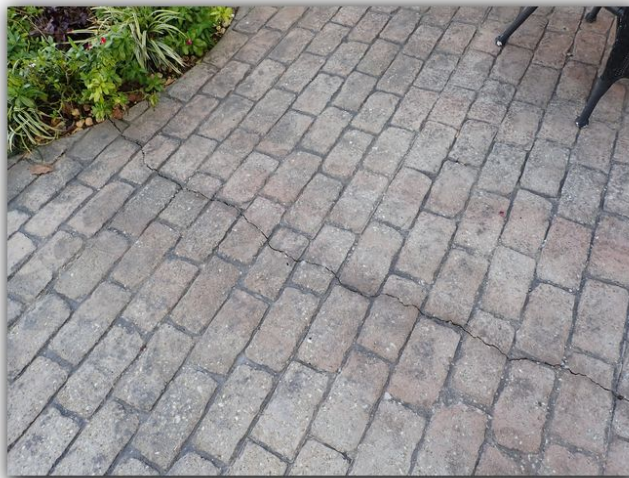
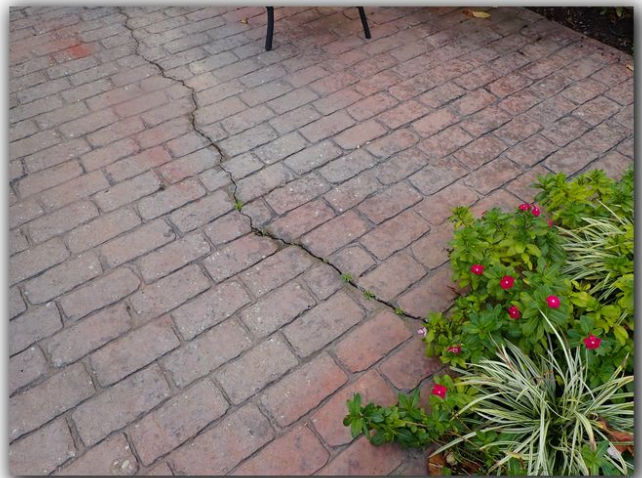
**Observations and Comments:** We observed general signs of cracking and surface deterioration throughout the stamped concrete patio in the condominium courtyard. Refer to the following photos.

Condominium Building Courtyard Component	Year
Courtyard Concrete Patio - Repair Allowance	2027 (5-year cycle)
Courtyard Gazebo - Repair Allowance	2027 (5-year cycle)
Courtyard Gazebo - Replace	2045
Courtyard Furniture - Replace	2030 (10-year cycle)

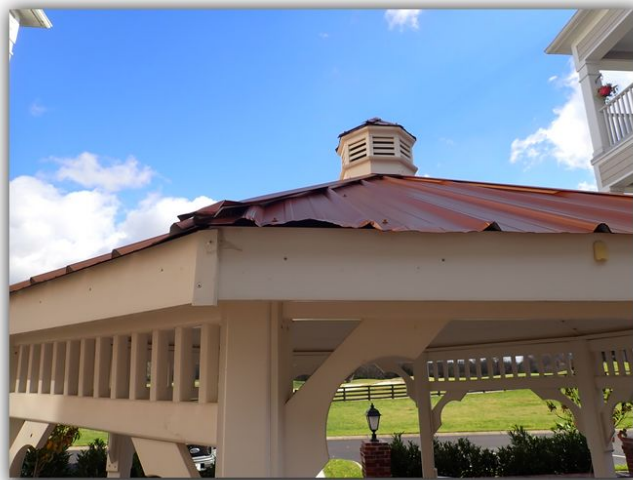
We observed some signs of minor damage along the edge of the metal gazebo roof covering in the condominium courtyard. Refer to the following photo.
